“An Unintended Discovery”

15kV Cable with Deadbreak Terminations Infrared Thermography Case Study

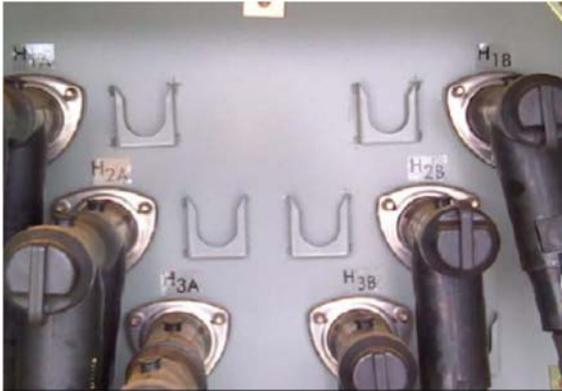
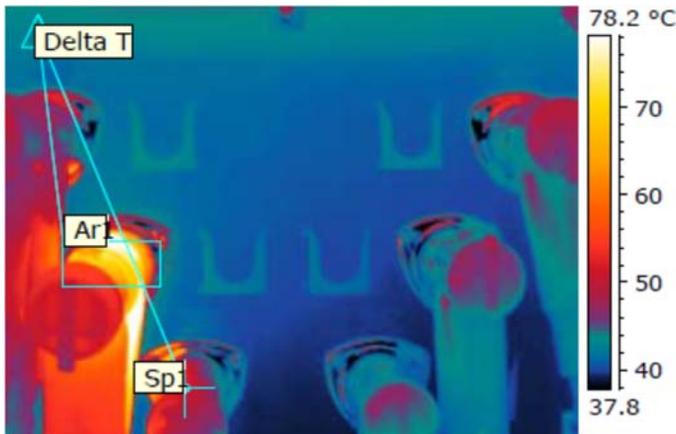
Atmospheric Temperature	20.0 °C
Ar1 Max. Temperature	89.3 °C
Sp1 Temperature	50.9 °C
Delta T Value	38.3

The AMP Technicians immediately notified the customer that the H2A double stacked deadbreaks on this transformer had a ~38°C temperature difference between its neighboring phases of H1A and H3A. This hot spot was not an expected part of the intended investigation, but was something that needed to be addressed immediately. After explaining the severity of the temperature differential by a technician, the customer then decided, due to plant production demands, to wait for the next scheduled outage, which was two weeks away to do any further investigation into what was causing the hot spot. Prior to the scheduled outage the customer was able to determine that loading was equal across all three phases and well within expected loads for that feed.

The customer outage was completed over a holiday weekend with a local electrical contractor investigating the deadbreak connections to determine what might be causing the hot spot. The following Cooper deadbreak double stack adapter was removed from the transformer.

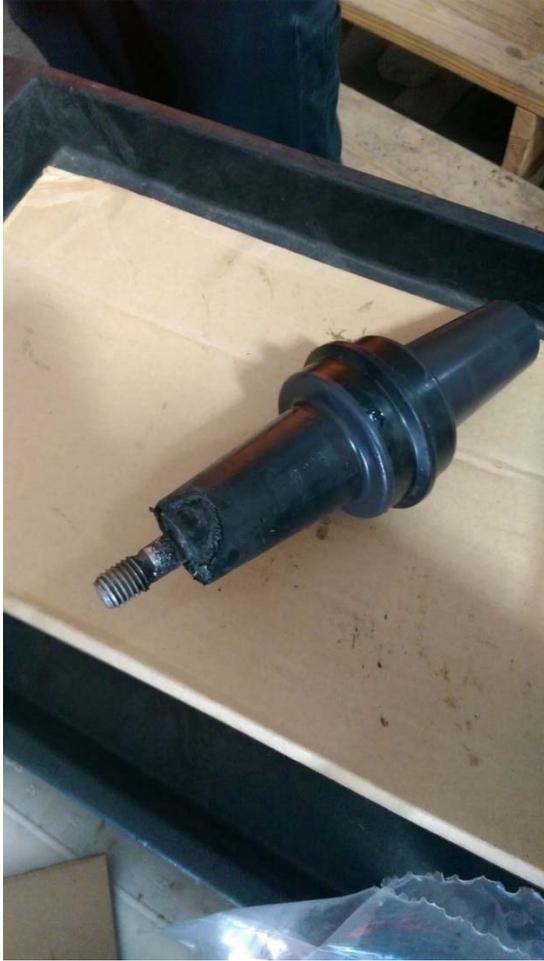
The electricians reported that the connections were finger-tight and appeared to have not been torqued. The loose connection between the two deadbreak termination connection adapters had generate heat due to a high resistance condition. AMP supplied a new termination kit to replace the damaged components and allow the transformer to be placed back into service by the time the outage was scheduled to be complete.
