AMP Quality Energy Services

“An Unintended Discovery”

15kV Cable with Deadbreak Terminations Infrared Thermography Case Study

By Jeremiah Evans

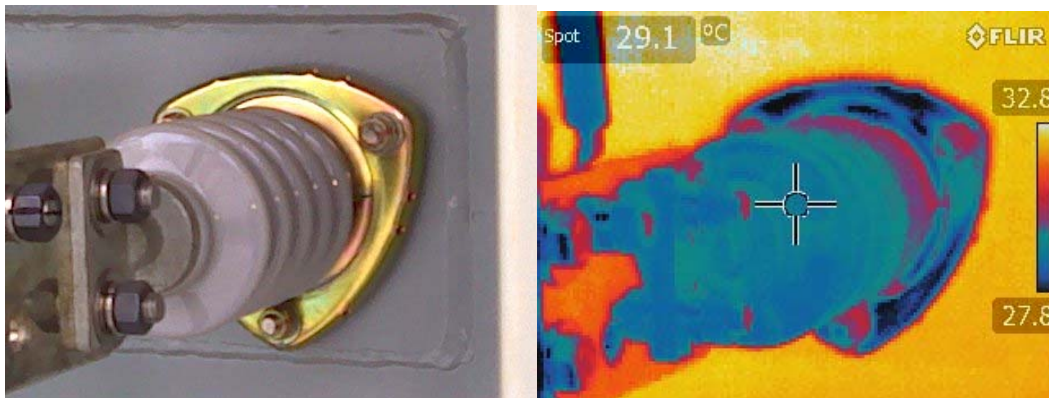
All of the IR and standard pictures taken displayed a normal temperature gradient across the three high side bushings of each transformer. An example of a Standard bushing pictures and its corresponding IR pictures are displayed below:

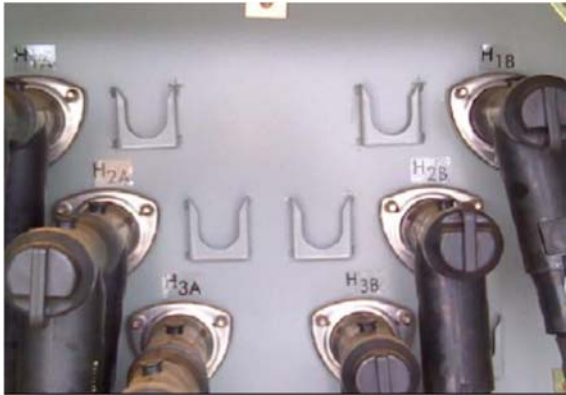
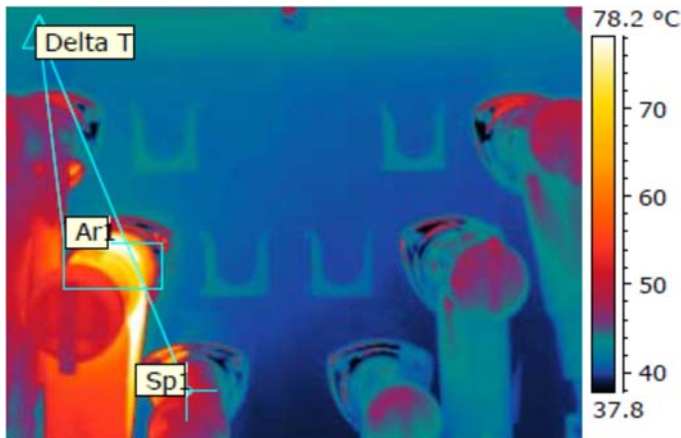
It wasn't until near the end of the second day of investigation that the team came across two transformers that had Cooper Deadbreak terminations instead of the two-hole lug terminations that had been present throughout the rest of the plant. The technician on site decided to go ahead and take a look at the deadbreak terminations, since they were there and the cabinet had been opened. The H1A, H2A, and H3A deadbreaks were fed from two sources and tied together via an adapter and double stacked 600A rated deadbreaks. The pictures below display what was witnessed and recorded:

Atmospheric Temperature	20.0 °C
Ar1 Max. Temperature	89.3 °C
Sp1 Temperature	50.9 °C
Delta T Value	38.3

The AMP Technicians immediately notified the customer that the H2A double stacked deadbreaks on this transformer had a $\sim 38^{\circ}\text{C}$ temperature difference between its neighboring phases of H1A and H3A. This hot spot was not an expected part of the intended investigation, but was something that needed to be addressed immediately. After explaining the severity of the temperature differential by a technician, the customer then decided, due to plant production demands, to wait for the next scheduled outage, which was two weeks away to do any further investigation into what was causing the hot spot. Prior to the scheduled outage the customer was able to determine that loading was equal across all three phases and well within expected loads for that feed.

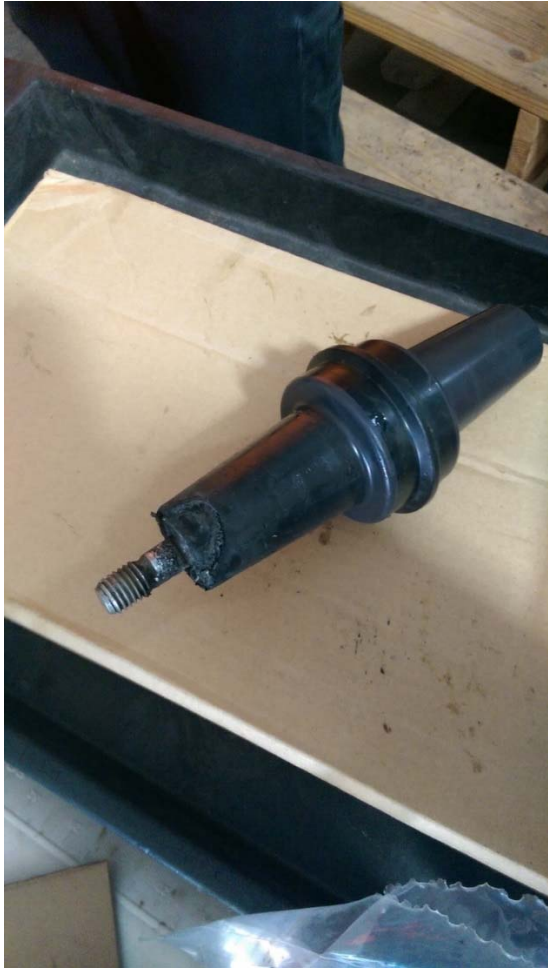
The customer outage was completed over a holiday weekend with a local electrical contractor investigating the deadbreak connections to determine what might be causing the hot spot. The following Cooper deadbreak double stack adapter was removed from the transformer.

The electricians reported that the connections were finger-tight and appeared to have not been torqued. The loose connection between the two deadbreak termination connection adapters had generate heat due to a high resistance condition. AMP supplied a new termination kit to replace the damaged components and allow the transformer to be placed back into service by the time the outage was scheduled to be complete.
