“An Unintended Discovery”

15kV Cable with Deadbreak Terminations Infrared Thermography Case Study

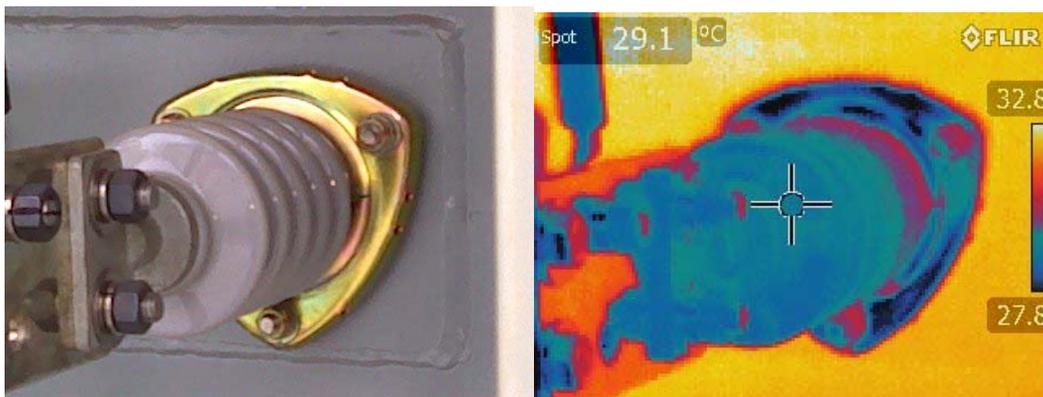
All of the IR and standard pictures taken displayed a normal temperature gradient across the three high side bushings of each transformer. An example of a Standard bushing pictures and its corresponding IR pictures are displayed below:
