AMP Quality Energy Services

“An Unintended Discovery”

15kV Cable with Deadbreak Terminations Infrared Thermography Case Study

By Jeremiah Evans

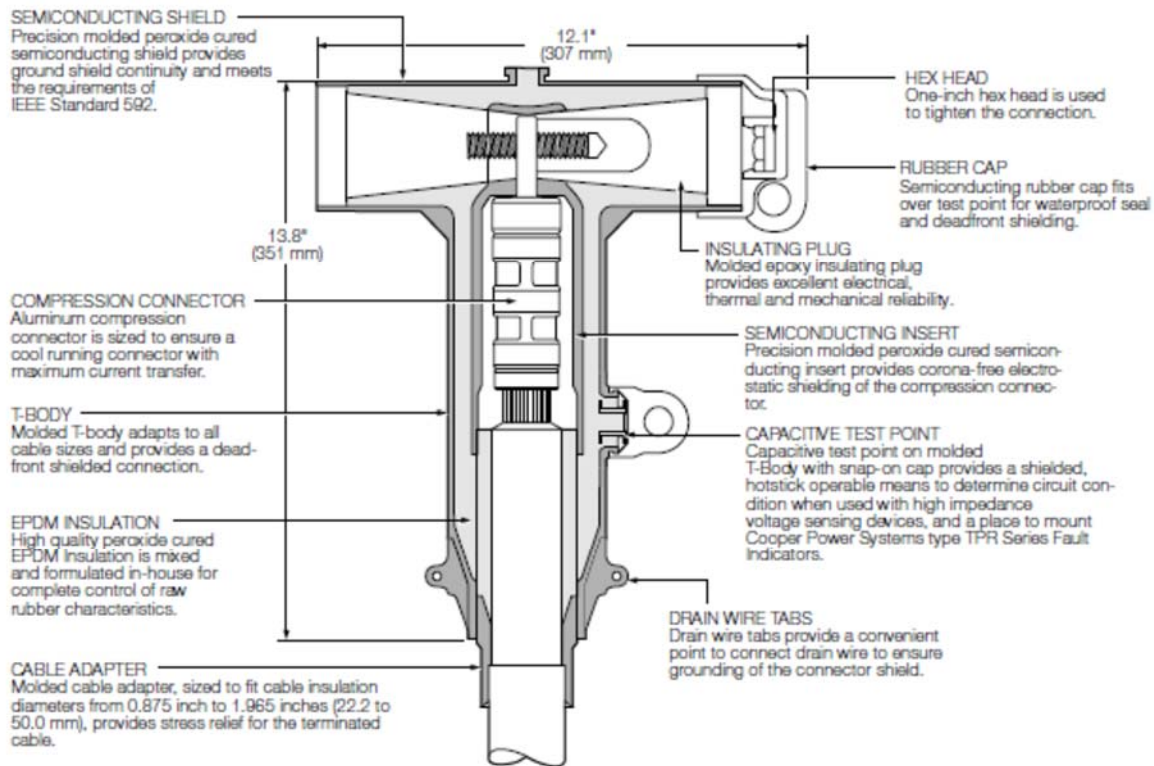
Figure 2.
Bol-T cutaway illustrates design features.

The AMP Technicians immediately notified the customer that the H2A double stacked deadbreaks on this transformer had a $\sim 38^{\circ}\text{C}$ temperature difference between its neighboring phases of H1A and H3A. This hot spot was not an expected part of the intended investigation, but was something that needed to be addressed immediately. After explaining the severity of the temperature differential by a technician, the customer then decided, due to plant production demands, to wait for the next scheduled outage, which was two weeks away to do any further investigation into what was causing the hot spot. Prior to the scheduled outage the customer was able to determine that loading was equal across all three phases and well within expected loads for that feed.
